# Manhole Inspection Summary

Manhole # S09AA2020MH

Insp Date: **7/17/06 10:13 AM**

**Location** Address: **5815 STUART AVE**

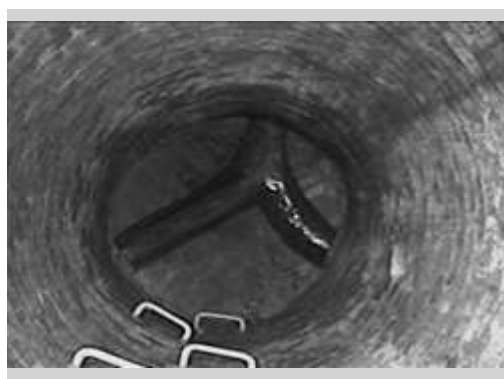
Defect

Corroded steps. Barrel infiltration.

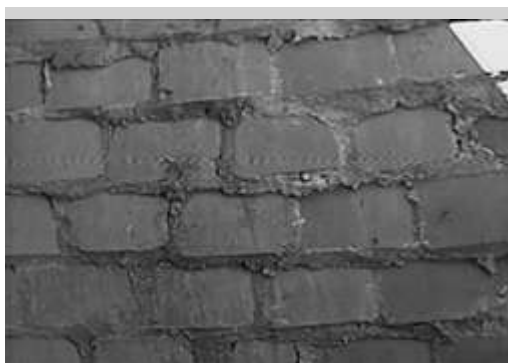
Defect

Corbel infiltration.

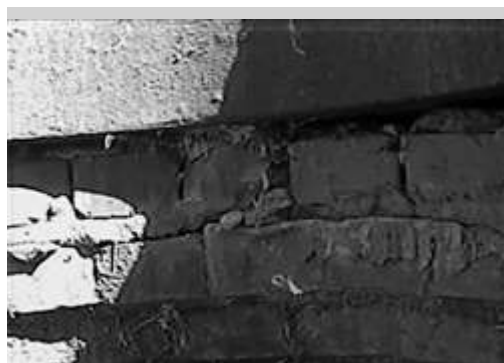
Adjustment deterioration and loose brick.  
Adjustment infiltration.

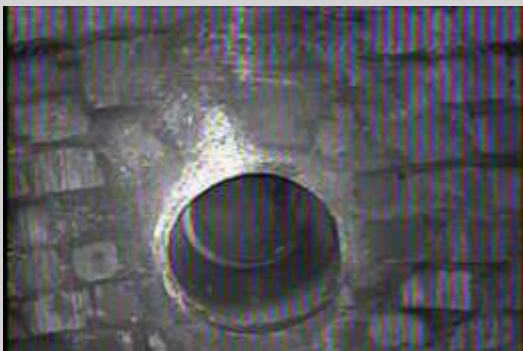
### 8 in. Circular Gravity Sewer Pipe In @ 4 O'Clock

Infiltration: **Evidence** Pipe Seal Cond: **Unknown**
